**SPRING LAKE DAM**

Missouri Inventory No. 30725

**Phase I Inspection Report**

**National Dam Safety Program**

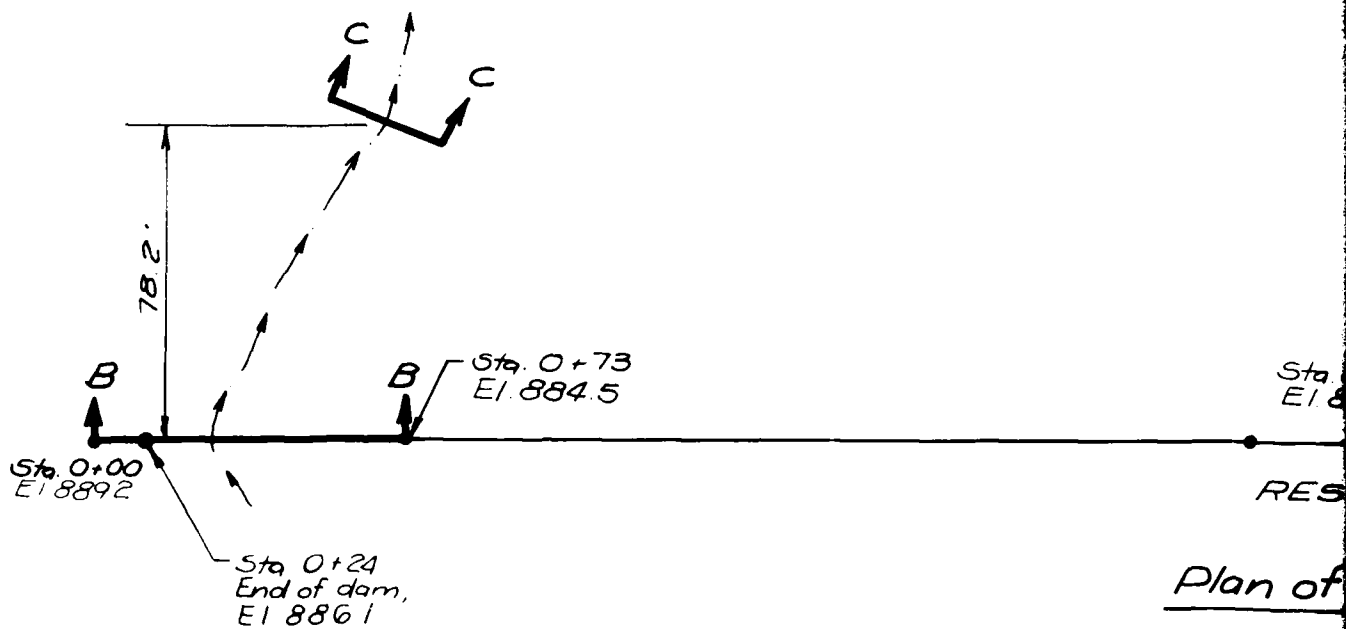
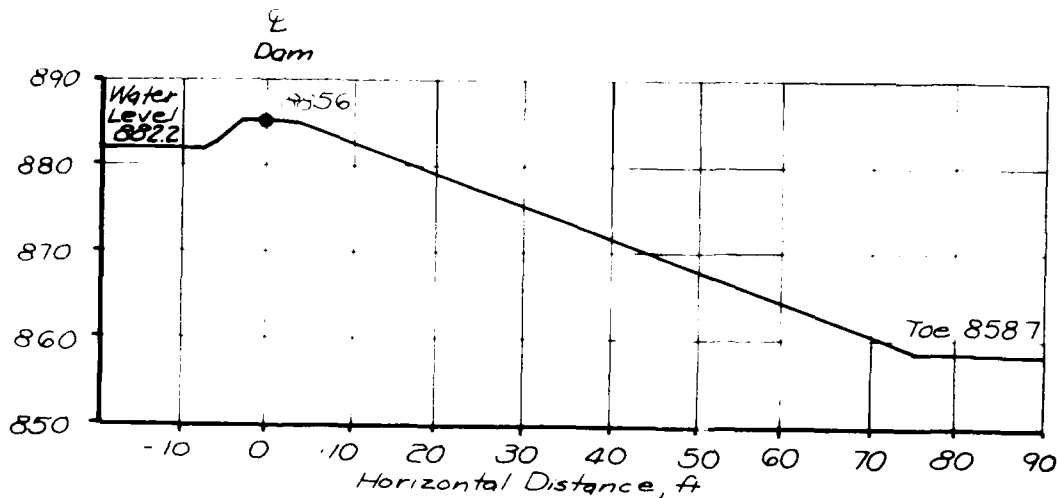
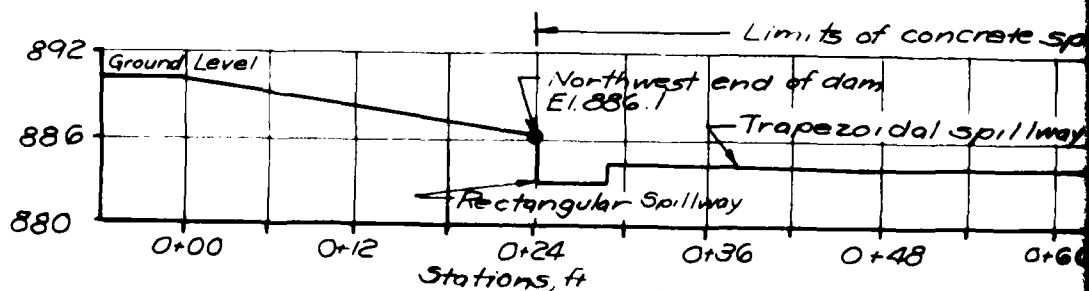
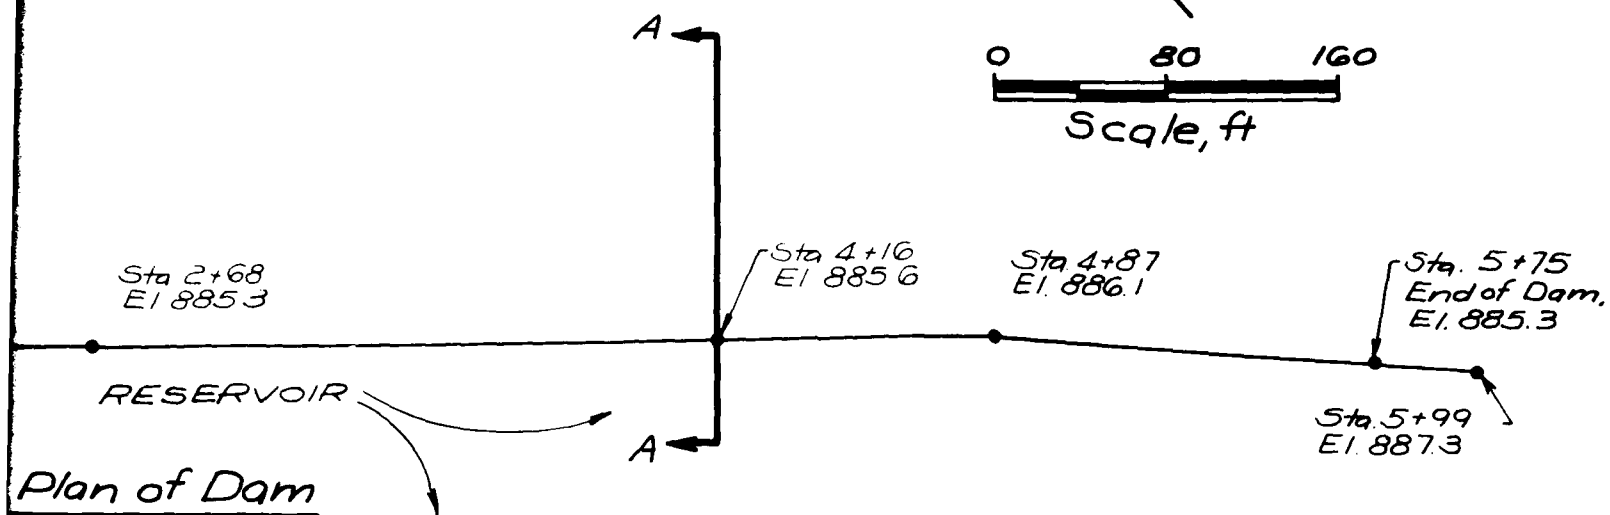
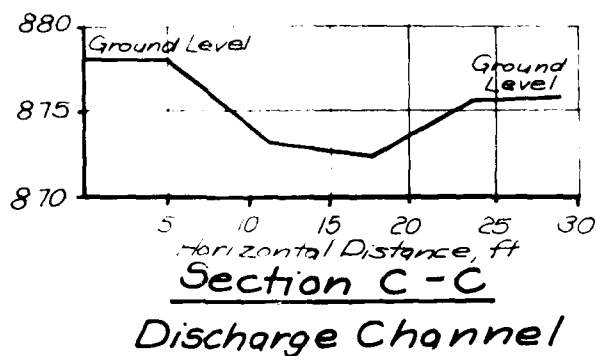
PLAN AND SECTIONS OF DAM AND SPILLWAY	
SPRING LAKE DAM	
MO. 30725	Fig. 3-A

Concern over adequate spillway capacity in 1979 prompted the Association to modify the spillway. The far left portion of the spillway, was widened 5.0 ft and deepened 1.4 ft as shown in Figures 3A and 3B and Photo 5. Although a land survey was completed for the reservoir area, the modification was done without formal engineering consultation.

1. Spillway. The spillway consists of a 43 ft wide, concrete lined, trapezoidal spill area and a concrete broad-crested weir. There is an additional five ft wide rectangular, low-level flow channel as shown in Photos 4 and 5 and Figures 3A and 3B. The concrete was in good condition with no spalling or cracking evident. At the interface of the concrete spillway and the downstream channel, however, substantial erosion of the soil has taken place.
